Chapter 1:

Condition Assessment

The intent of this condition assessment is to independently evaluate the condition of Going-to-the-Sun Road. This assessment includes both a review of what had previously been investigated, concluded, and recommended regarding the condition of the Road, and an independent field reconnaissance.

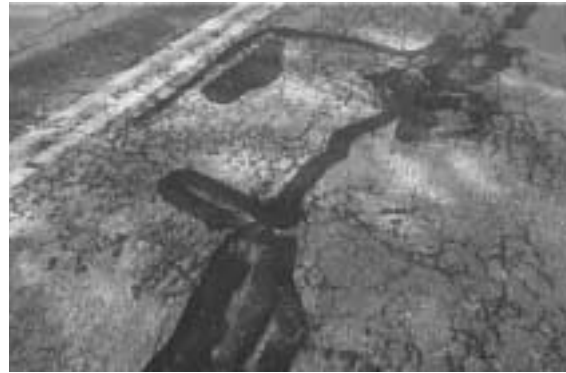
Various stages of road distress were noted throughout the remainder of the route (MP 16.2 to 43.0) including surface chipping, longitudinal and transverse cracking, rutting, shoulder raveling, shoulder and edge-of-road subsidence, alligator cracking, and surface treatment (patching) to correct for settlement. Figures 3 and 4 illustrate advanced stages of pavement distress encountered on the Road.

Figure 3: Cracks reaching down into the roadbed.

Appropriate repair of the areas outlined above will require removal of the existing failed asphalt; improved drainage where necessary to remove the unstabilizing force of water from the roadbed; potential removal of the roadbed material and replacement with correctly sized, placed, and compacted road base; and placement of new asphalt surface.

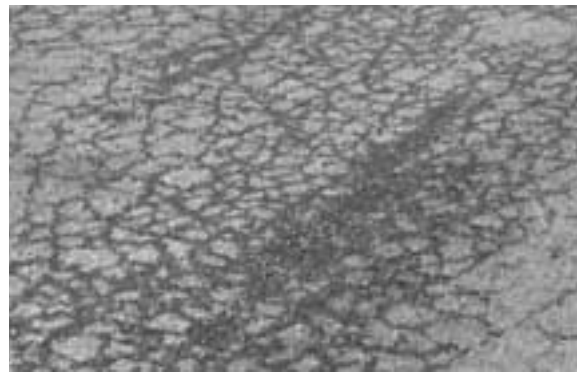
Figure 4: Alligator cracking

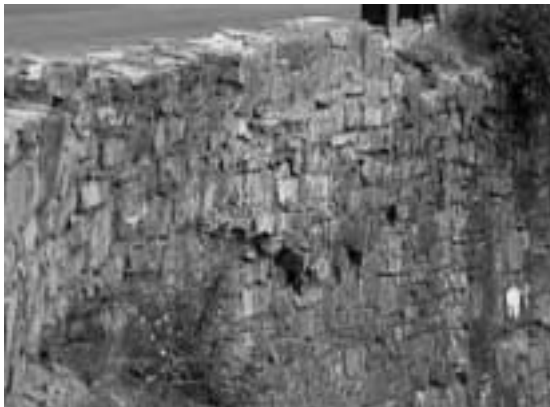
Figure 5: Retaining wall at MP 27.58

MP 27.58 As shown in Figure 5, this wall (34 feet high and 160 feet long) has suffered significant lateral displacement, most likely due to

subsurface saturation and poorly compacted subgrade. The mortar has been eroded from the rock masonry joints, and vegetation has taken root in the resultant cracks and crevices.

The five retaining walls that are damaged beyond practical repair are listed below (MP numbers and wall dimensions are taken from the 1998 FHWA Wall Inspection Report Data Base). These walls must be rebuilt. This rebuilding can reuse the original stones to preserve the historic character of the walls.

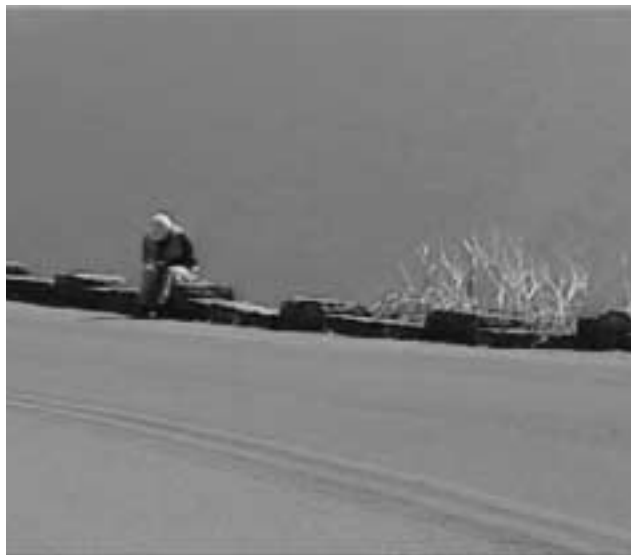
Many of the stone guardwalls have settled and/or their height has been encroached upon by pavement overlays or patching. This results in the wall not being high enough in many places to serve its intended purpose of keeping errant vehicles from leaving the roadway.

Figure 6: In some cases the distance from the top of the roadway to the top of the guardwall is as little as six inches.

In some cases the distance from the top of the roadway to the top of the guardwall is as little as six inches, (rather than 18 to 24 inches, as illustrated in Figure 6. Some of the stone guardwalls appear to have been reconstructed or repaired with a mortar consisting of fine sand, such as would be used for brick or concrete masonry work. As illustrated in Figure 7, this mortar has almost no strength, and can be readily crumbled by hand.

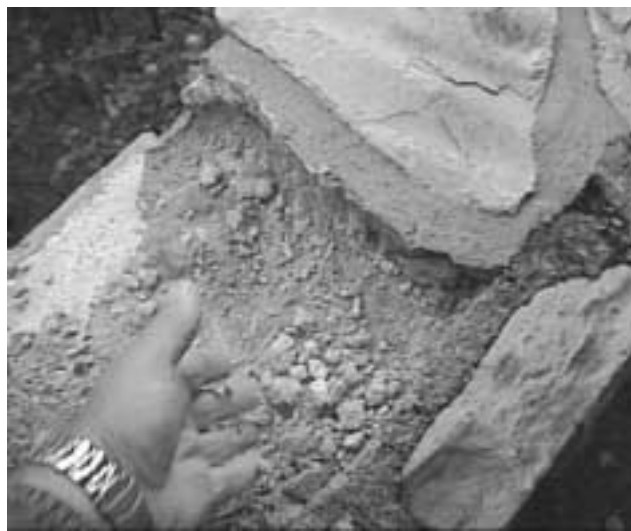
Figure 7: Replacement mortar consisting of fine sand has almost no strength, and can be readily crumbled by hand.

The original mortar was constructed of native sands and contains red and blue pebbles about one-eighth inch in diameter. In general the original mortar is in fair condition except for the surface joints which have been exposed to weathering. As mentioned previously, moss and other vegetation are growing on many mortar surfaces, contributing to the deterioration of the exposed surfaces.

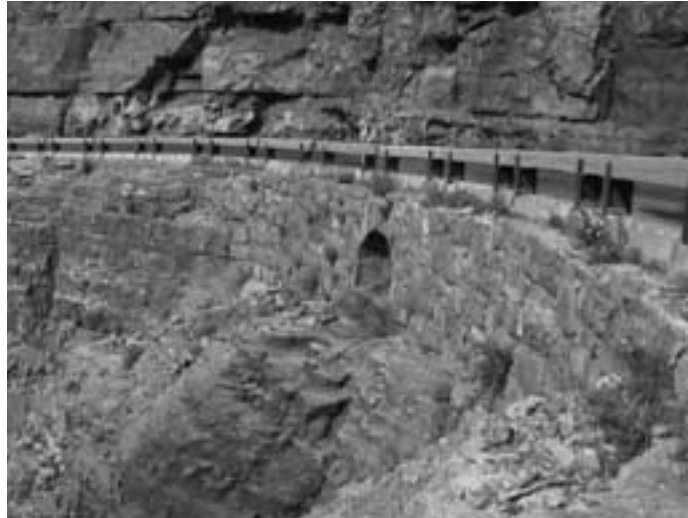
- Removable Sawed Timber Rail and Steel Post on Concrete Foundation.** These guardrails function as “removable” rails in avalanche zones and are generally in good condition (Figure 8); however, the FHWA has recently conducted a review of the crash worthiness of these systems and has concluded that they do not meet crash safety standards. These removable guard rail systems are non-historic. It is recommended that these guard rails be replaced. This replacement could be wood-veneered removable guardrail meeting crash-test and aesthetic requirements, or avalanche-resistant stone guardwall (see sidebar discussion).

Figure 8: Removable sawed timber rail and steel post on concrete foundation is not historically acceptable, and does not meet FHWA crash safety standards.

The sawed timber rail and steel post removable guardrail is not historic and its use should not be proliferated. Because it is historically inaccurate, existing installations should be removed. An acceptable alternative, in historic stone guardwall locations, is avalanche-resistant stone guardwall. This is a concrete stem wall with stone veneer that looks like original guardwall. Round-log guardrail designs have been historically used in some other locations, the reuse of this design may be considered.

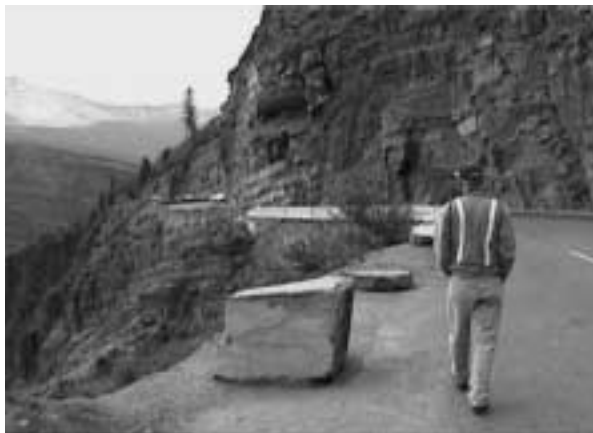
- Large Barrier Rock.** Large barrier rocks are used in many areas to delineate the edge of the roadway or parking areas (Figure 9). These barrier rocks are considered a hazard in that they do not offer a continuous

Figure 9: Large barrier rocks are generally being used to block vehicles, and are not historically accurate.

smooth transition through constricted areas, and may cause severe damage to impacting vehicles.

Barrier rocks are not historically accurate and are not desirable. Most have been added since the 1950's or 60's. They should be removed. In most areas their use is to block vehicles from informal pullouts. These pullouts were created in many cases by road maintenance activities that resulted in excess earth and rock material being deposited alongside the road, resulting in a wide spot near the road. The most historically correct action would be to remove the slide debris from alongside the Road and recontour the slope. Alternatively, the debris area could be revegetated. Either way, the informal pullout would no longer exist and the barrier rocks could be removed.

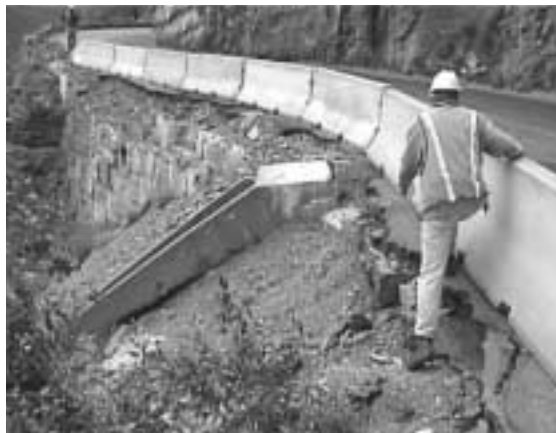
Figure 10: Temporary concrete "Jersey" Barriers replace missing guardwall, a dramatic visual departure from the original.

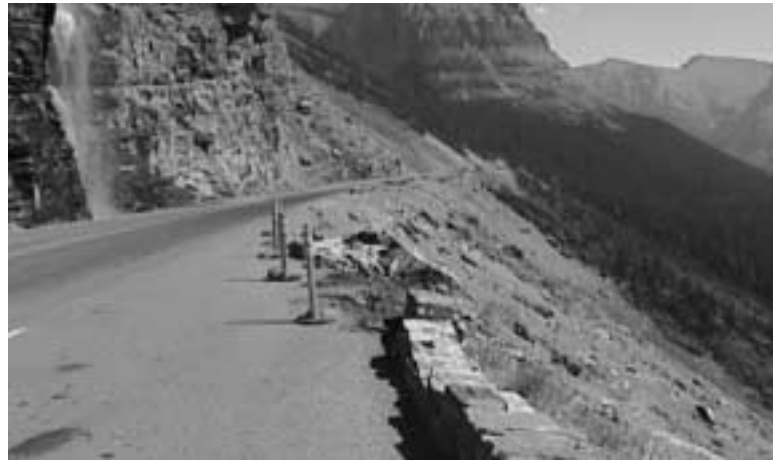
Figure 11: MP 33.0, east of the East Tunnel

One candidate for replacement is located at MP 33.0 east of the East Tunnel, illustrated in Figure 11. At this location the hillside is encroaching into the roadway causing a narrowed road section where drivers' attentions are already distracted due to the prominent roadside waterfall and the optical effect of driving out of the dark tunnel into the sunlight. An extension of the retaining wall and guardwall in this area would restore the original roadway width and provide protection for errant drivers.

Installation of new guardwall should be considered at several potentially hazardous locations. An acceptable avalanche-resistant stone guardwall or

round-log guard rail could be used in these cases.

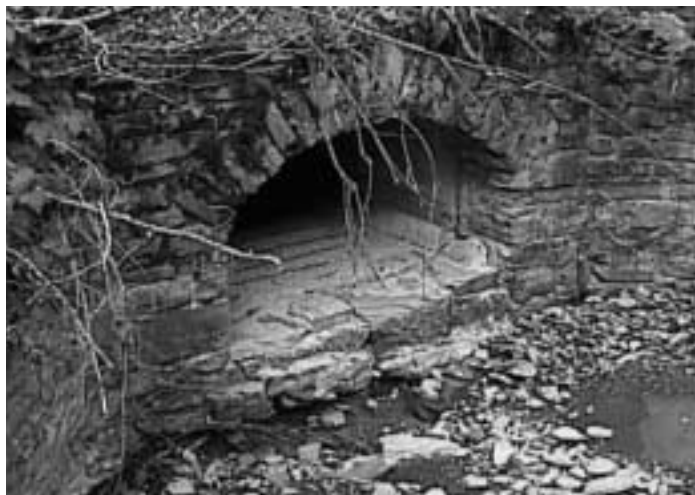
- **Box Culverts and Bridges.** Box culverts and bridges along the Road are generally in fair to good condition, though notably not well maintained. Cleaning and repointing of the rock walls of these structures is needed throughout the length of the Road, in addition to repairs to the base of box culverts such as at MP 21.25 (see Figure 12, pag 24). Rock and debris abrasion has eroded the bottom of these culverts to the degree that reinforcing steel has been exposed, promoting further deterioration.

Figure 12: At MP 21.26, abrasion from rock and debris have eroded the bottom of the culvert, revealing the horizontal reinforcing bars.

Repairing the base slab of the concrete box culverts presents no challenge to the historic character of the Road.

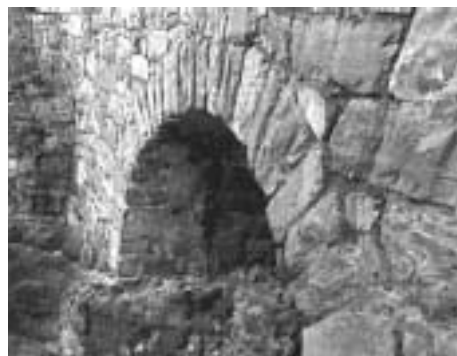
Figure 13: Crystal Point Arch at MP 24.56, just east of the Loop.

- **Stone Arches.** Most of the stone arches along the Road are in good condition except for minor to moderate mortar deterioration and weathering. One notable exception was observed at MP 24.56 just east of the Loop (Figures 13, 14, 15, and 16). Known as the Crystal Point Arch, it exhibits advanced stages of failure. A portion of the foundation of this arch has collapsed, resulting in a void

approximately three feet deep, six feet wide, and eight feet long directly under the traveled way. Further voids were found within the outside foundation of the arch. The pavement directly over this arch has settled significantly as a result of the loss of road base over the arch. This site has been identified by the FHWA for repair, and

design plans have been completed for this work pending availability of funding (a copy of a portion of the plans is exhibited in Appendix D). Repair of this structure is considered **critical**. Disassembly of the arch will probably not be required for its repair.

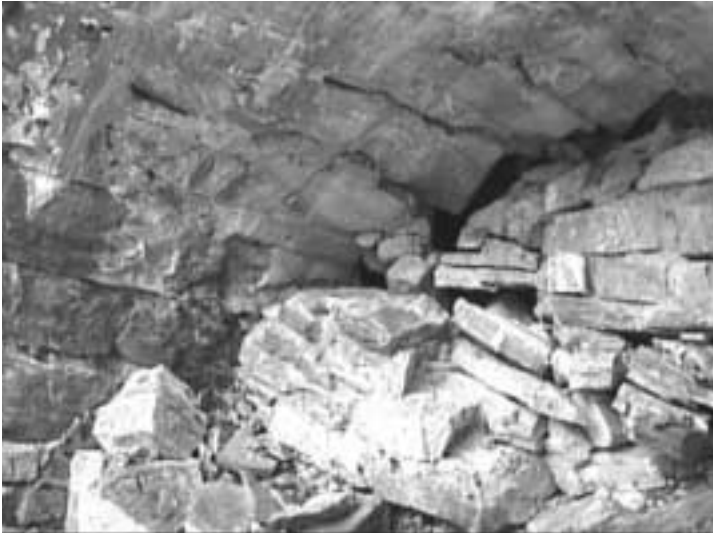
Figure 14: A portion of the foundation of Crystal Point Arch has collapsed.

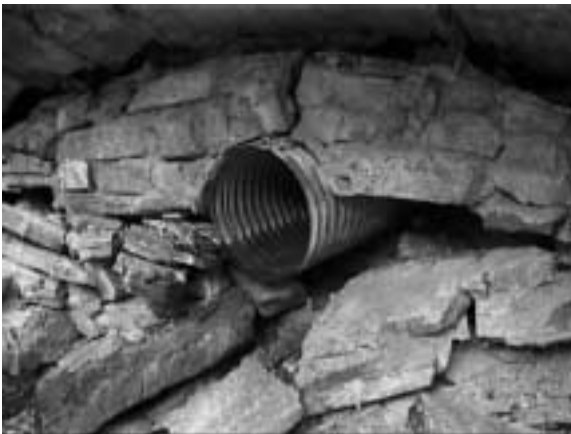
Figure 15: Corrugated metal culvert underneath Crystal Point Arch

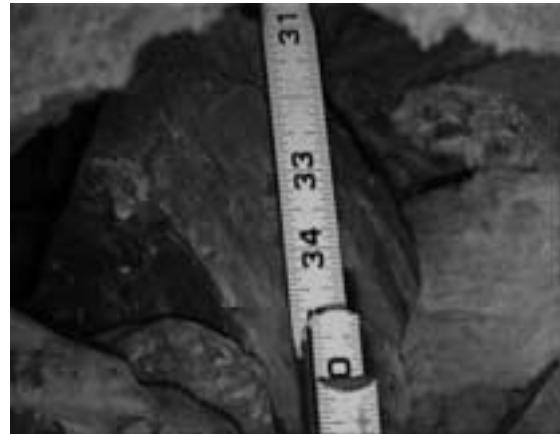
Figure 16: A void has developed directly under the traveled way.

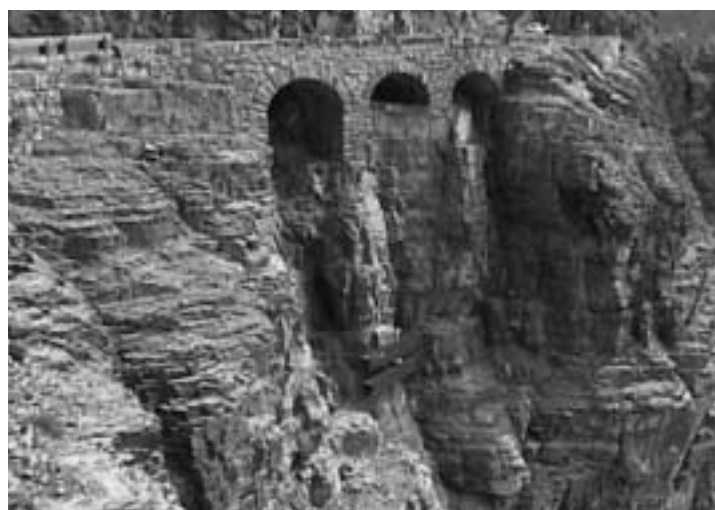
Figure 17: At Triple Arches, MP 29.8, deteriorating supports are shored up (detail below).

- **Triple Arches.** Deteriorating supports and guardwall sections were observed at MP 29.8 (Triple Arches). As shown in Figure 17, emergency corrective action has been taken by FHWA to shore up the weakened bearing rock support columns. Although unsightly, this FHWA repair was effective. Additional stabilization efforts may be warranted in the near future to further shore up the structural bearing capacity of the retaining walls, adjacent rock stratum, and other structural elements, and to rehabilitate the guardwall sections.

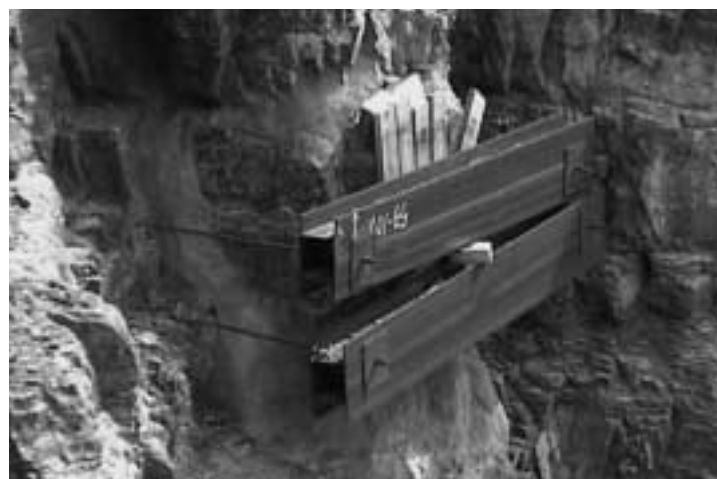
Figure 18: FHWA's emergency corrective action used steel I-beams to shore up the weakened bearing rock support columns.

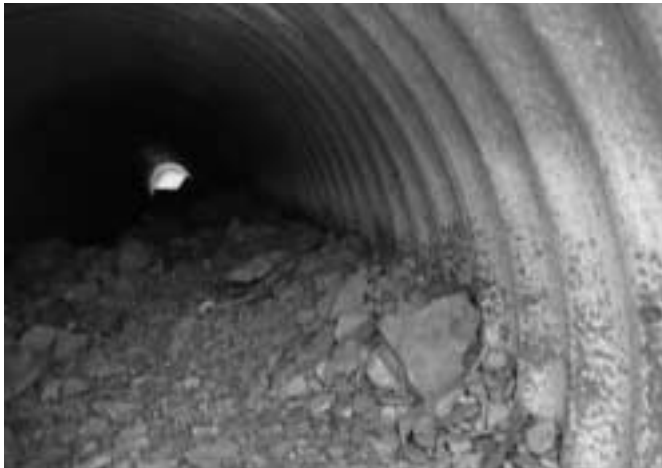
Figure 19: Rock and debris partially fill the entrance and interior of most corrugated metal culverts, inhibiting drainage flow.

- **Culverts.** Most culvert crossings were generally in fair to good condition, with the exception of certain concrete box culverts which showed evidence of abrasion and deterioration as mentioned above. Corrugated metal pipe culverts appeared to be sound, with very little evidence of corrosion and only occasional incidents of abrasion. In some areas (particularly just west of Logan Pass) the drainage structures appear to be undersized for

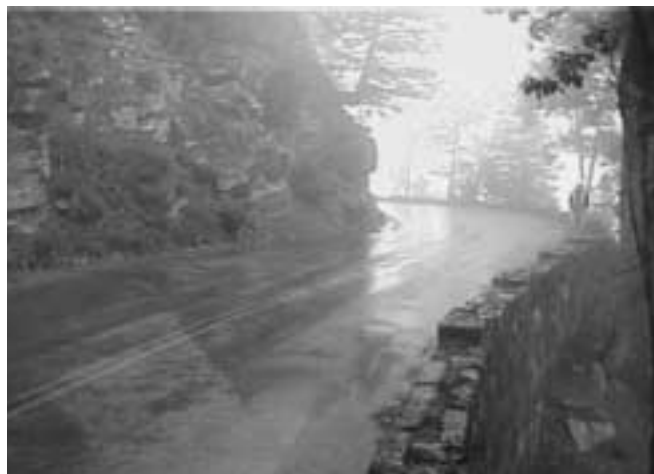
A few locations were noted where natural drainage flowed onto and across the Road as illustrated in Figure 20. Additional drainage culverts or properly placed cross drains would alleviate these problems.

Figure 20: In some areas natural drainage flows onto and across the Road. Additional culverts or cross drains would alleviate these problems.

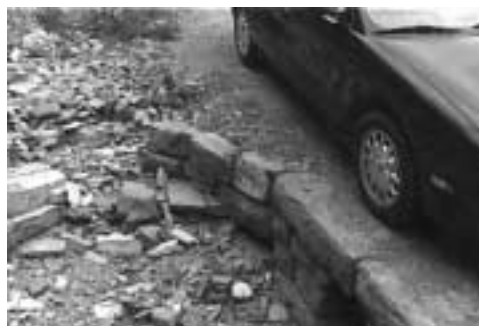
Figure 21: A roadside catch basin presents a hazard to vehicles.

Historically correct protection of roadside catch basins would involve placing log barriers in front of the basins to block cars from them. These log barriers would be removed to facilitate snow plowing. Replacing these catch basins with drop inlets would not be acceptable.

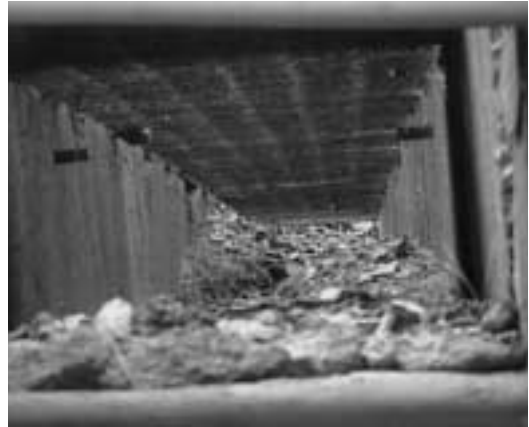
Figure 22: A cross drain is choked with debris, rendering it ineffective.

Refurbishment, maintenance, and the addition of necessary drainage facilities is considered a **high priority** throughout the length of the Road. Road damage resulting from water intrusion into the highway pavement and base was especially evident in the Alpine Section.

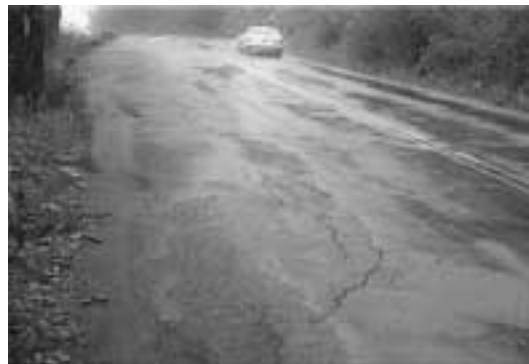
Figure 23: Weakened fill underlying the road.

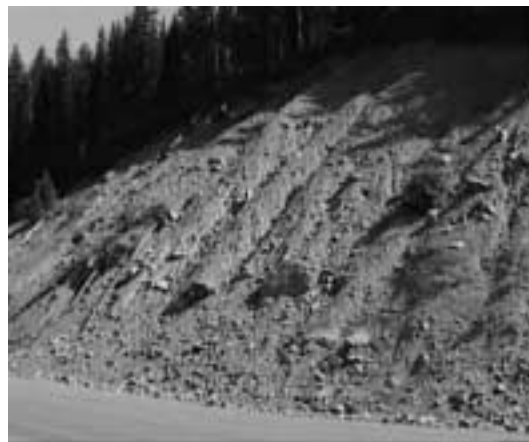
Figure 24: Weakened fill adjacent to the road.

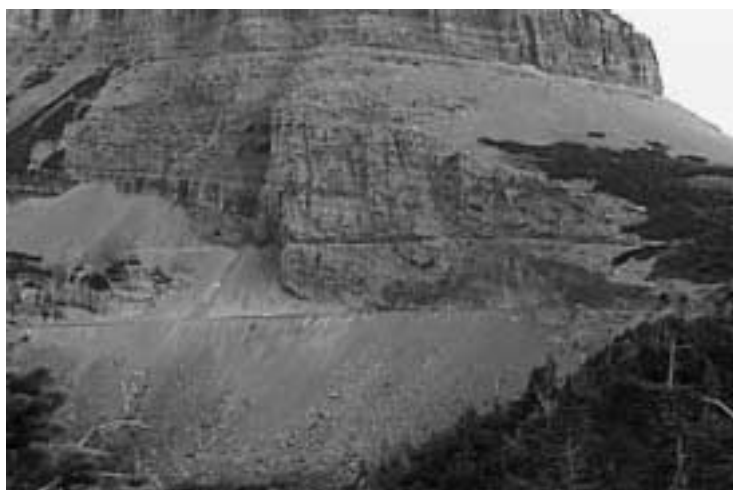
Figure 25: The most severe rockfall area is the quarter-mile section just west of Logan Pass.

- **Unstable Slopes Above the Road.** Unstable backslopes with potential landslides and rockfall hazards are considered a serious safety issue throughout most of the alpine section extending from about one mile west of the west tunnel (MP 22.3) to two miles east of Siyeh Bend (MP 36.2). The most severe “rockfall” section is the quarter mile section just west of Logan Pass, shown in Figure 25 (page 30). The Siyeh Creek and Haystack Creek
